THE CALIFORNIA EARTHQUAKE OF APRIL 18, 1906

REPORT

STATE EARTHQUAKE INVESTIGATION COMMISSION

VOLUME I, PART I

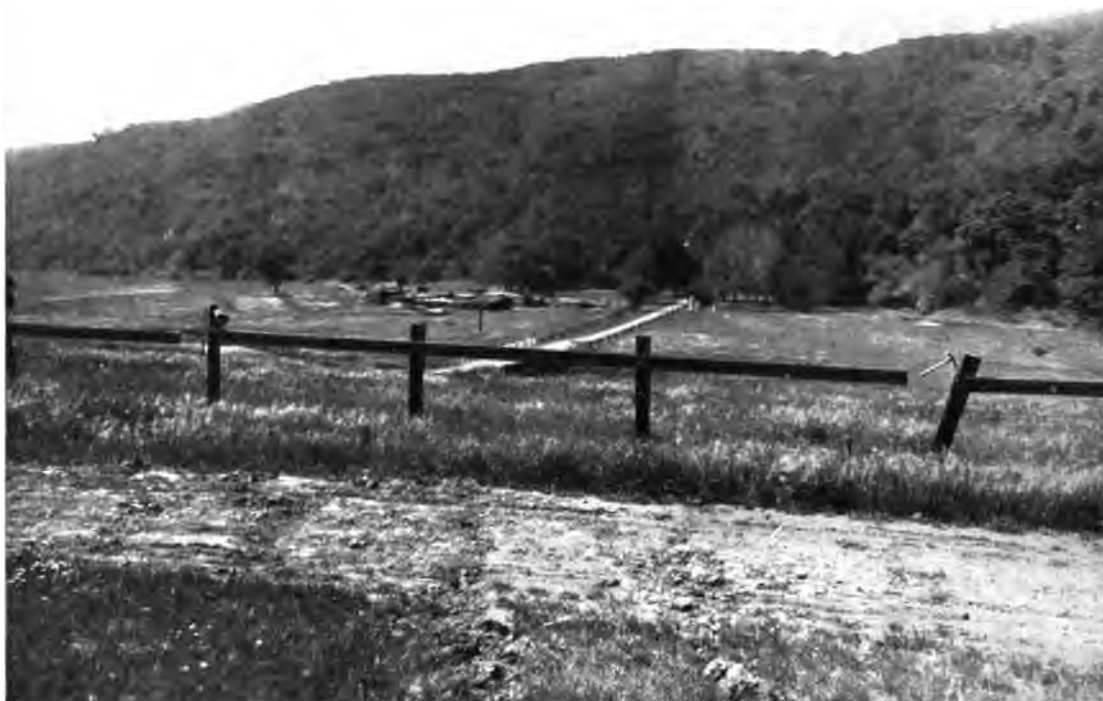
A. The Rift valley between San Andreas Lake and Crystal Springs, looking southwest. Fault-trace parallel to fence about 50 feet beyond. Auxiliary cracks in the foreground at an angle of  $40^\circ$  with it. J. C. B.

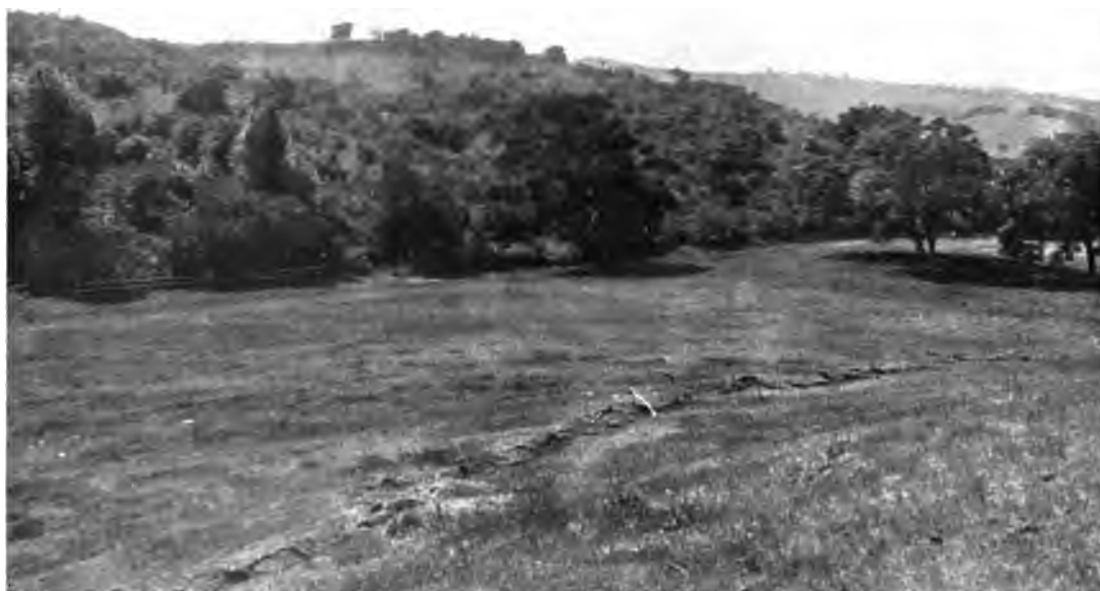
B. The Rift valley 5 miles west of Stanford University. Fault-trace in foreground. Per J. C. B.

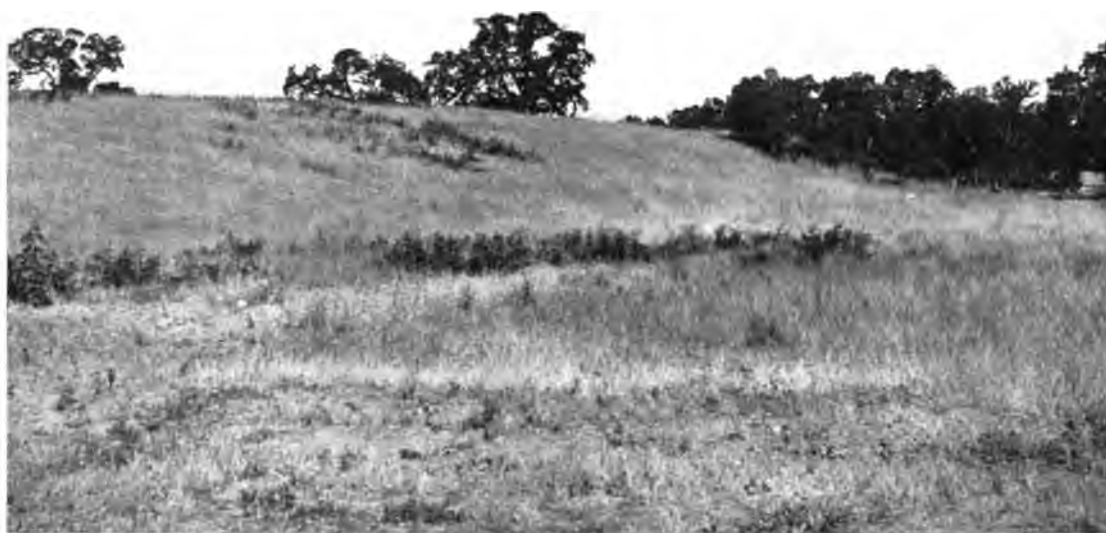
The Rift can be traced thru the hills at the head of the Cholame Valley by its characteristic features, as well as by bluffs which are undergoing rapid erosion. It crosses the road a mile west of Parkfield and exhibits here a regularly rounded ridge 200 feet wide and 20 feet high at the most elevated point. (Plate 19B.) That the ridge must be hundreds of years old is shown by the great oak trees that are growing upon it. One white oak is fully 8 feet thru. Large springs mark the fissure at this point, and are found along it the whole length of the Cholame Valley. According to a resident, the Rift opened along the ridge in the earthquake of 1901, the opening being distinctly traceable for several miles. Southeasterly from the point just described thru the Cholame Valley, there appears no very prominent ridge or escarpment, altho springs and cienegas, marking a gentle swell in the flat open surface of the valley, indicate the line of the Rift.

B. Ancient scarp on the line of the Rift a mile west of Parkfield, Cholame Valley. H. W. F.

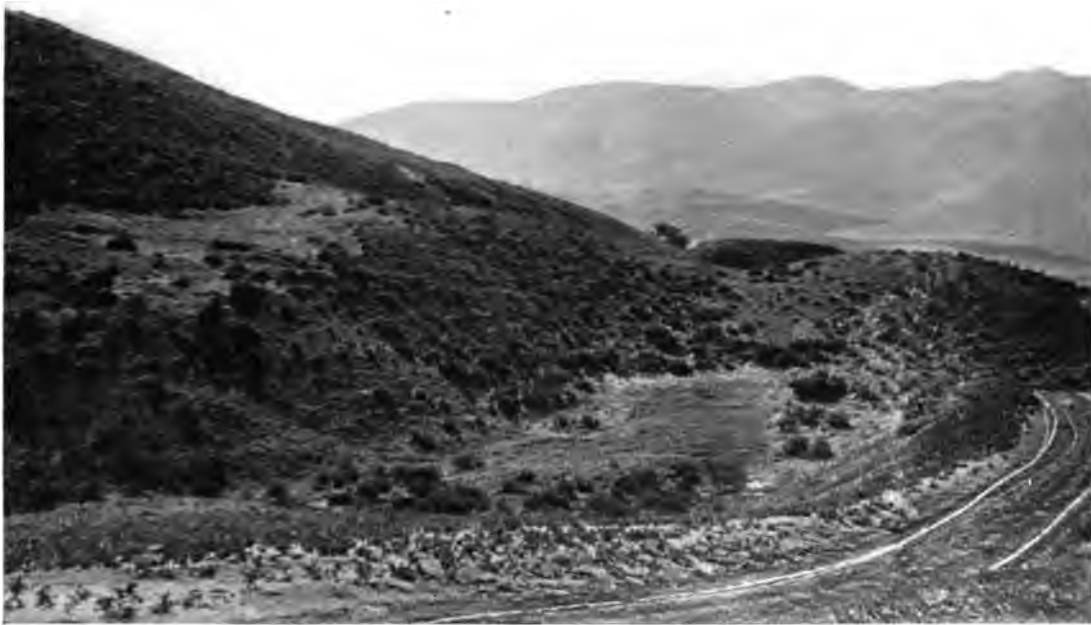
A. Looking west along the Rift from Cajon Pass, showing double scarp. H. W. F.

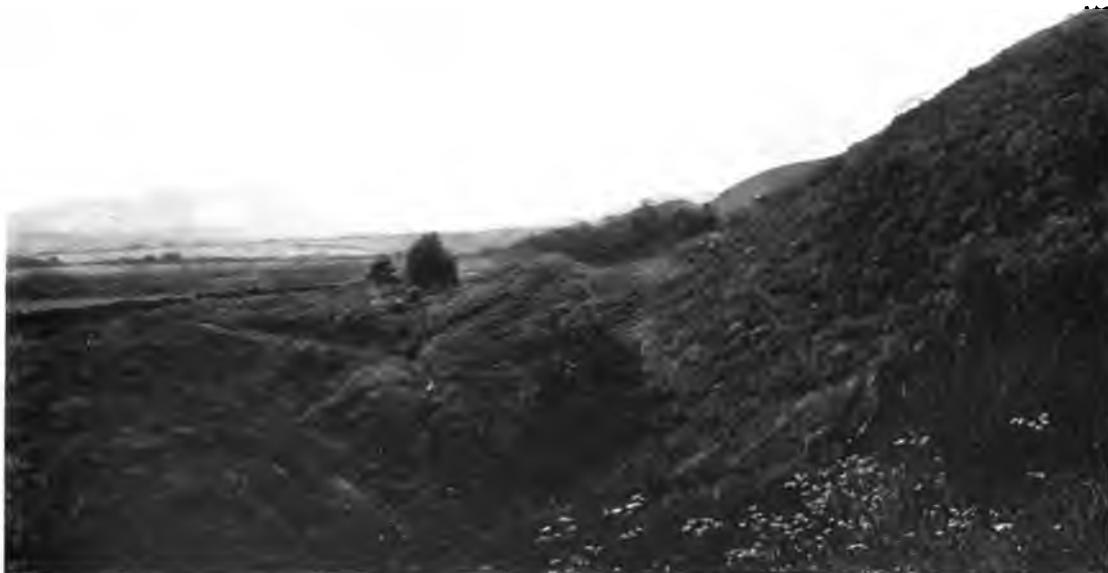
B. Double fault-scarp in Rift north of Highland, at base of San Bernardino Range. H. W. F.

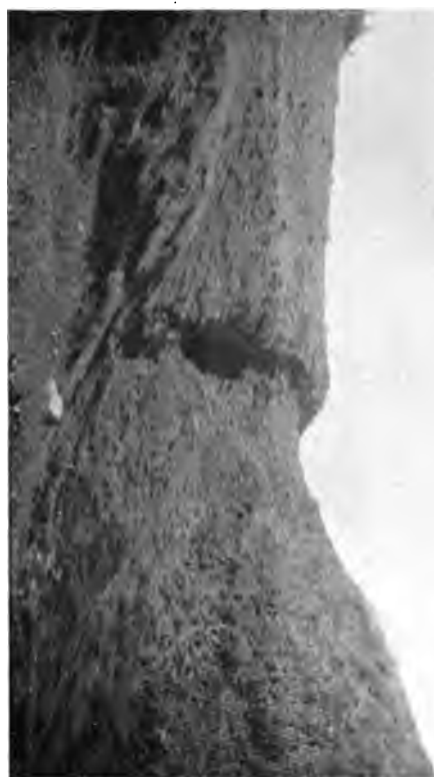
A. Fault-scarp passing thru saddle at head of Wood Gulch, looking south-southeast.  
F. E. M.

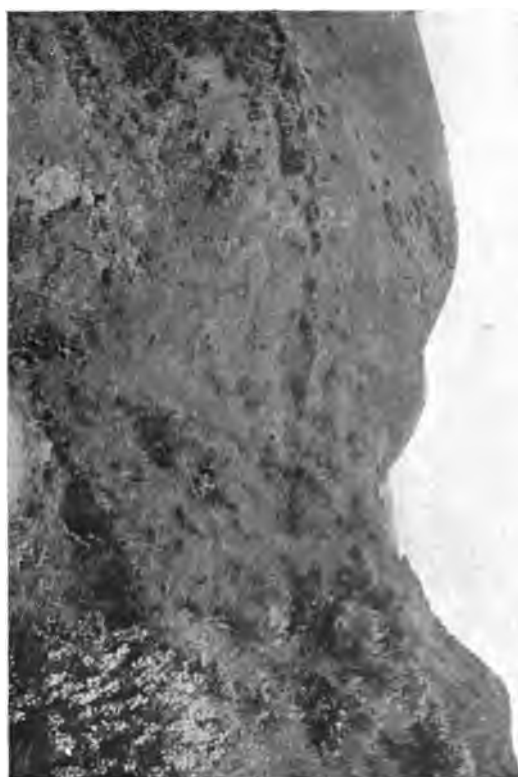
B. Auxiliary fault-trace following old scarp in saddle between Wood Gulch and Humboldt Creek. F. E. M.

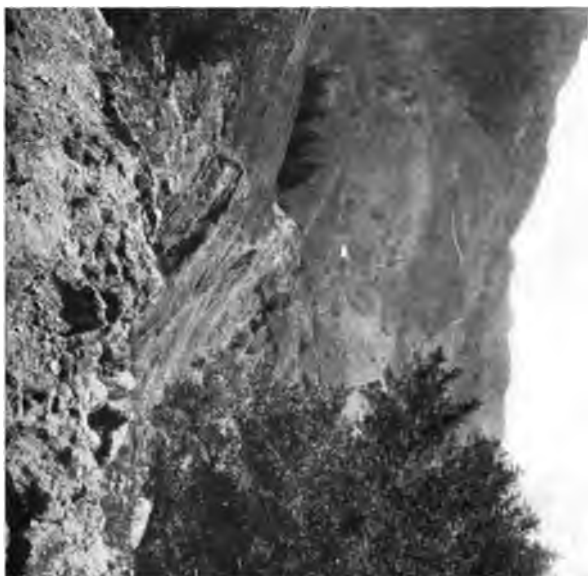
south slope of Telegraph Hill, following for a considerable distance a characteristic fault feature on the steep brushy spurs indicated in plate 31b. Immediately south of the summit of Telegraph Hill the disturbance is the most pronounced, being accompanied apparently by an upthrow on the west side, resulting in a sharp-crested ridge some 4 feet high. It is possible, however, that this ridge is not the result of the recent disturbance, but of a former one, modified into a more acute form by the shaking off of the sod. (See plate 31c.) From the summit of Telegraph Hill a bearing was taken over the entire length of the line down to Shelter Cove: N. 25° W. Projecting the line north from the hill on the azimuth, it appears to head for a number of high mountains of the King's Peak Range, altho no visible traces of the disturbance are found north of Telegraph Hill. Immediately north of its crest is the upper end of a great hopper-like landslide, clean swept for over a thousand feet. The fault-trace is entirely obliterated by this slide. The exact location of the fault north of Telegraph Hill was not ascertained. Under the

C. Looking south-southeast from Telegraph Hill along fault-trace marked by sharp-crested ridge in foreground, with upthrow of  $4 \pm$  feet. F. E. M.

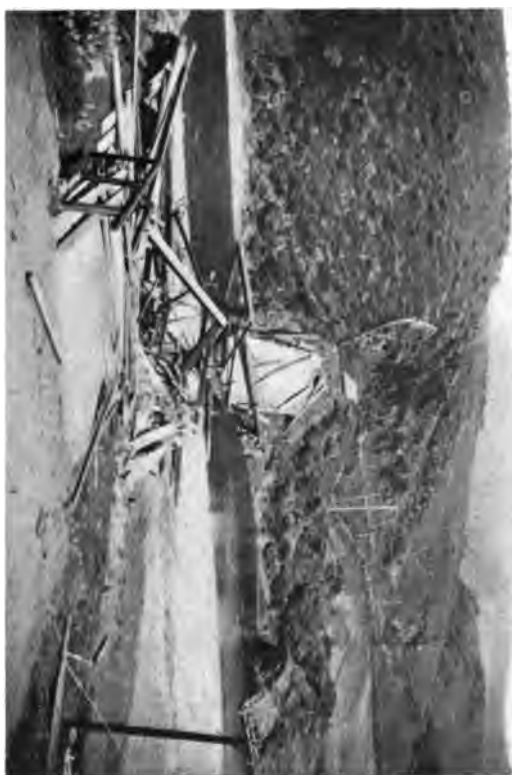
Southeast of this point, the fault-trace follows the broad stream bed of Alder Creek for nearly a mile, passing beneath a bridge, the wreck of which is shown in plate 32B. In this view, the horizontal offset of the bridge along the fault-line is well shown. It is apparent that this offset is not less than the width of the bridge. On the southwest side of the stream, near the bridge (A, fig. 12), the fault-trace is flanked by peculiar, isolated, rocky knobs similar to that on the northeast side. It is not clear, however, that these rocky knobs have more than an accidental relation to the fault, since they may possibly be residual sea-stacks upon the uplifted wave-cut terrace.

B. Fault passing under bridge over Alder Creek. Bridge displaced not less than its width. F. E. M.

The wagon bridge over Alder Creek (plate 32B), which stood astride of the fault, is a complete wreck. The timbers broke in many places, and the tension rods were twisted and in some cases actually ruptured.

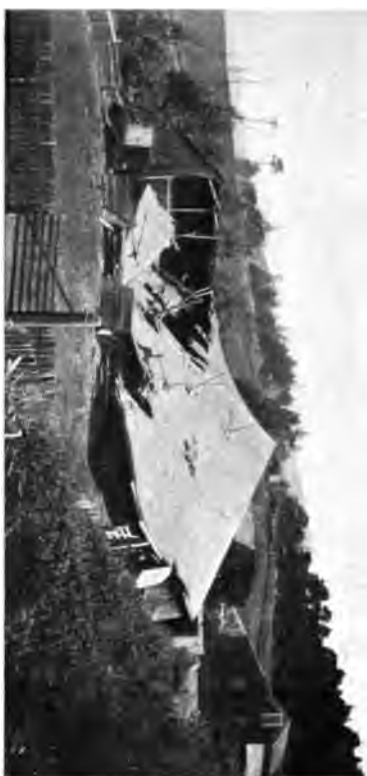
C. Barn of E. E. Fitch, north of Manchester. Across the fault. F. E. M.

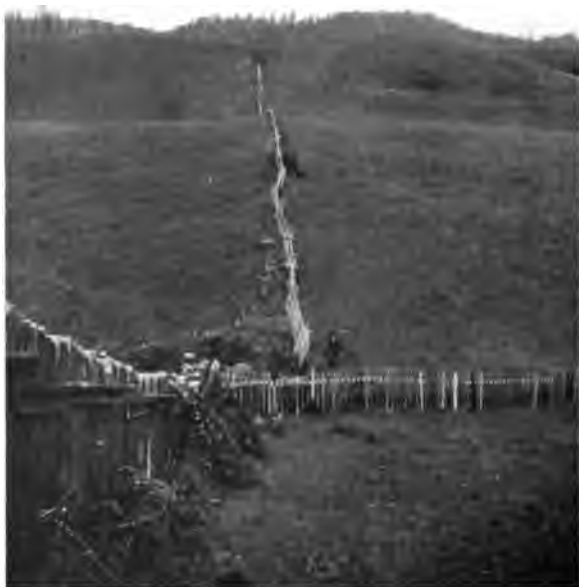
A. East-west fence near saddle between Garcia River and Brush Creek. Main offset 13 feet. Auxiliary offset 2.5 feet in middle ground. F. E. M.

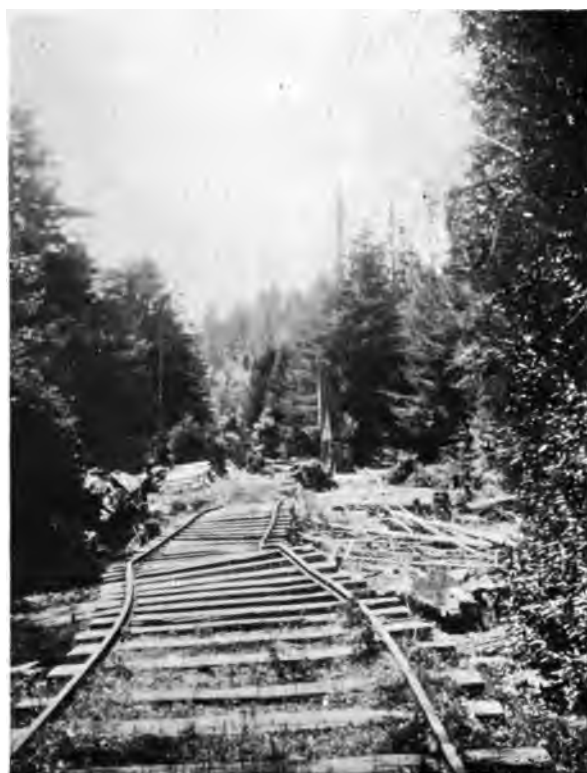
B. Small railway trestle, Little North Fork Gualala River, looking north. Main fault-trace 100 feet to right. Auxiliary crack under trestle. F. E. M.

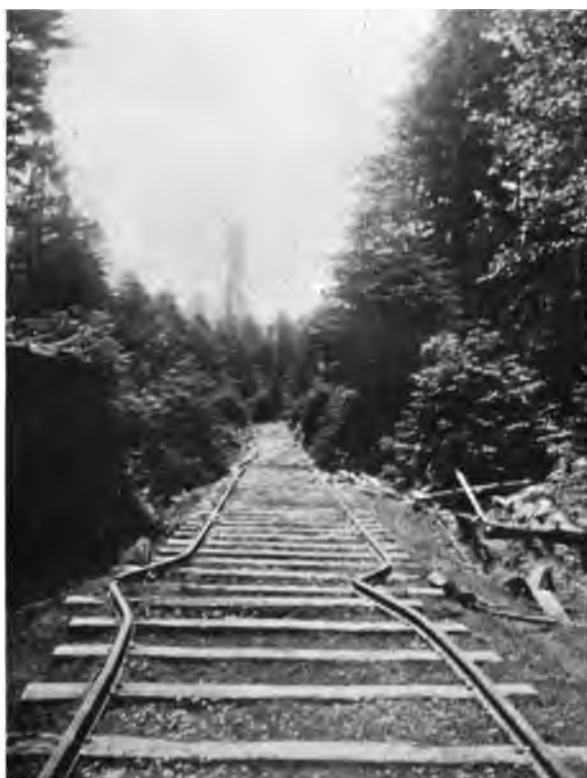
Down the Little North Fork, the fault-trace follows the axis of the valley on its west side; at a point 1.5 miles north of its junction with the North Fork it runs lengthwise for over 100 yards with the grade of an abandoned logging railroad, tearing the same to pieces. Interesting evidence of the condensation or shortening of the ground in this vicinity is afforded by the buckling of the rails as seen in plate 33b. Here the main line of dislocation lies about 100 feet to the east of the track in the stream bed. The effect of the movement was to shorten the steel rails either by buckling or telescoping after the snapping off of the fish plates. The small trestle in the distance is traversed at an acute angle by an auxiliary line of dislocation and is similarly shortened. At the locality shown in plate 33c, the buckling in the foreground resulted in the breaking of the rails. Similar instances of the shortening of the steel are shown in the distance. Here the main line of dislocation of the earth lies about 50 feet to the east of the track, and parallel with it. Plate 33B is a nearer view of the trestle above referred to. Below this point the fault-trace lies in the stream bed for some distance, crossing the North Fork at a point 200 feet east of its junction with the Little North Fork. Two lines of faulting appear here, both of which caused considerable damage to the railroad track; but the latter having been repaired before the date of Mr. Matthes' visit, no measurements of offsets were obtainable.

C. Buckled track, Little North Fork Gualala River. Both rails broken. Fault-trace parallels track 50 feet to left. F. E. M.

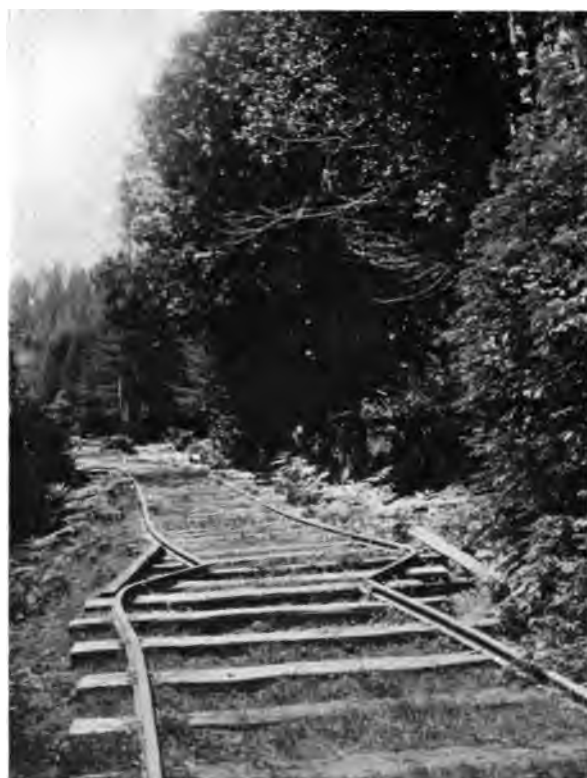
D. Buckled track, Little North Fork Gualala River. Fault-trace 100 feet to left. F. E. M.

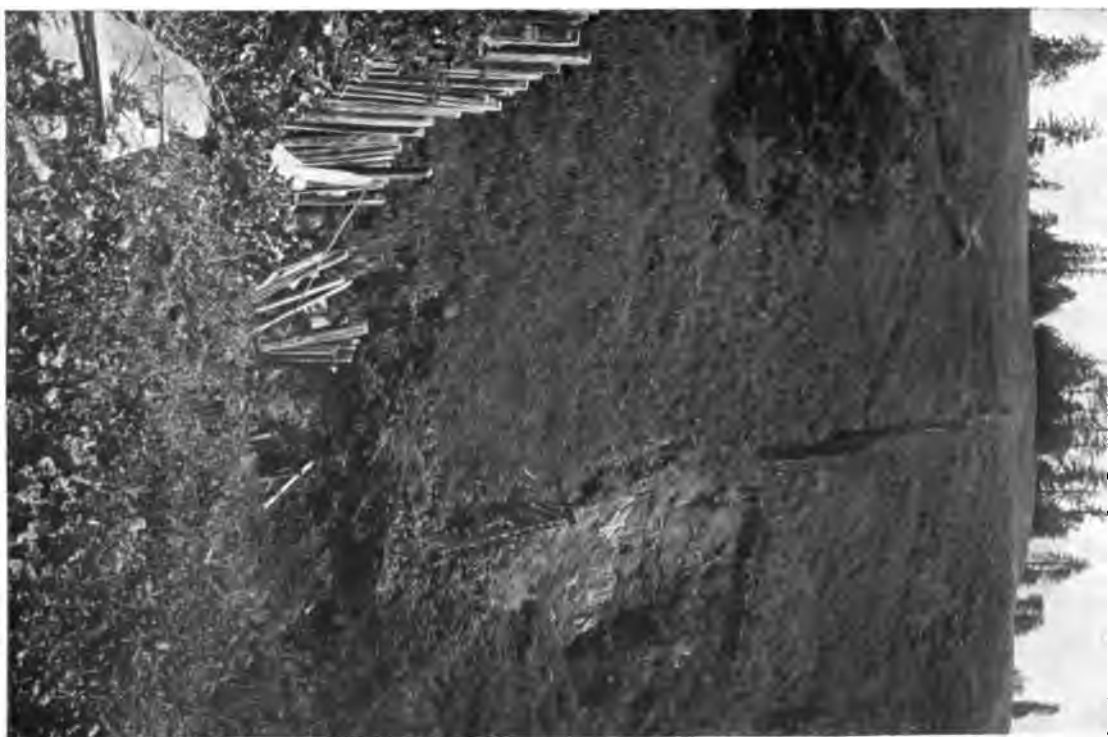
B. Dislocation of fence near Fort Ross. J. M. L.

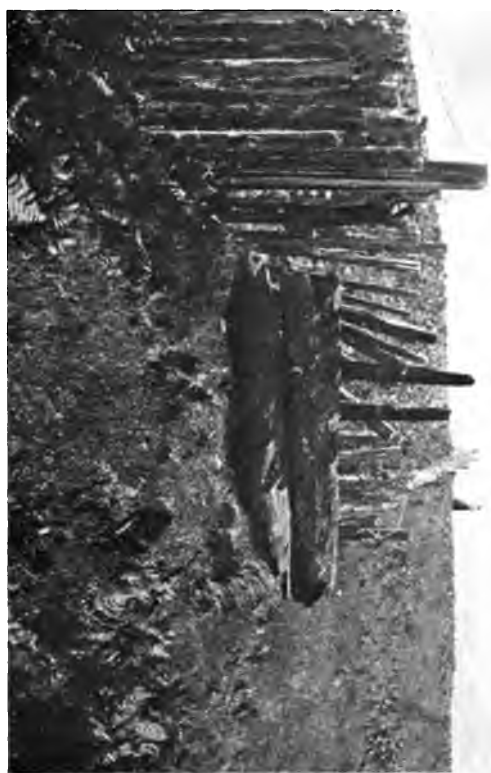
A. Offset of 8 feet on fence a mile east of Fort Ross. R. S. H.

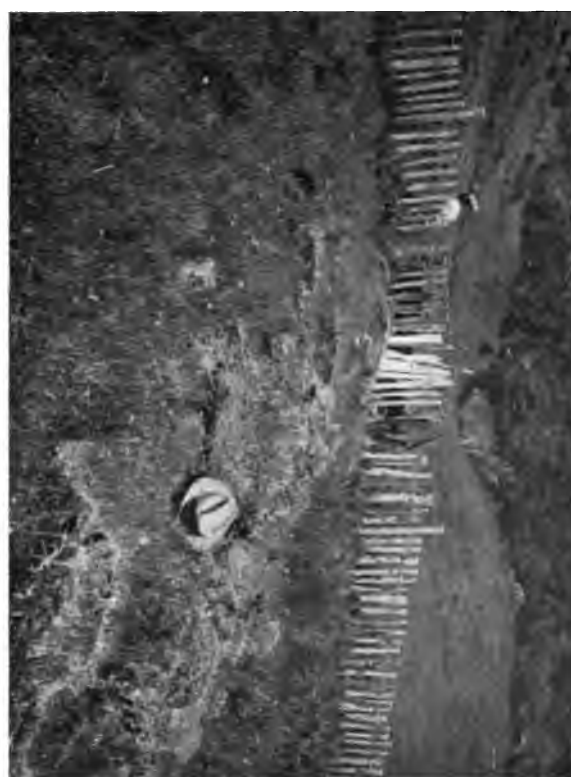
B. Fault-trace and dislocated fence near Fort Ross. R. S. H.

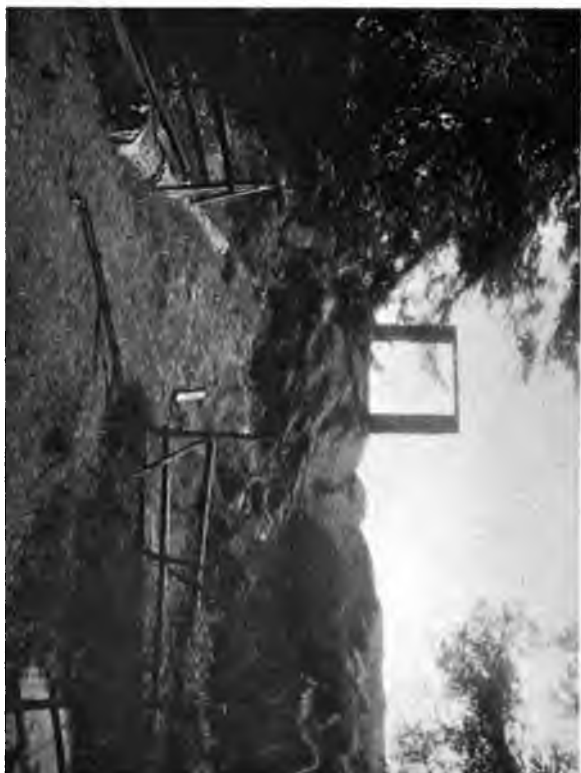
C. Roadway offset 12 feet. New fault-scarp 3 feet high, facing northeast. Above Fort Ross. F. E. M.

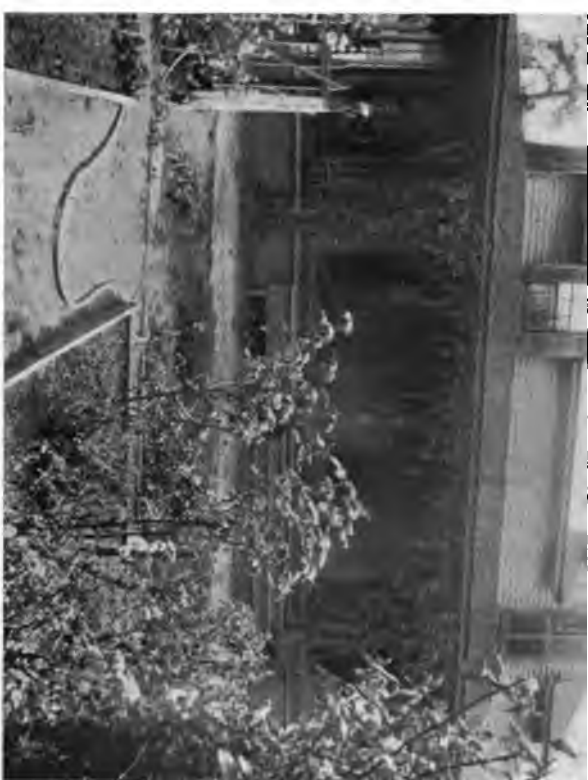
D. Fault-trace between garden and house, Skinner's ranch, near Olema. Before earthquake center lines of path and steps were coincident; afterwards offset was 15 feet 9 inches.

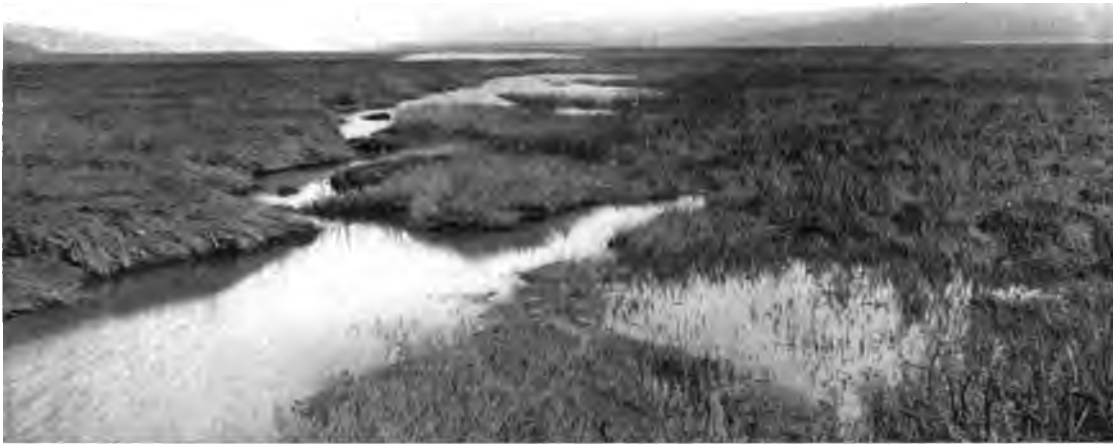
A. Fault-trace on Papermill delta. Looking northwest. The water lanes are largely at right of main line of fracture. G. K. G.

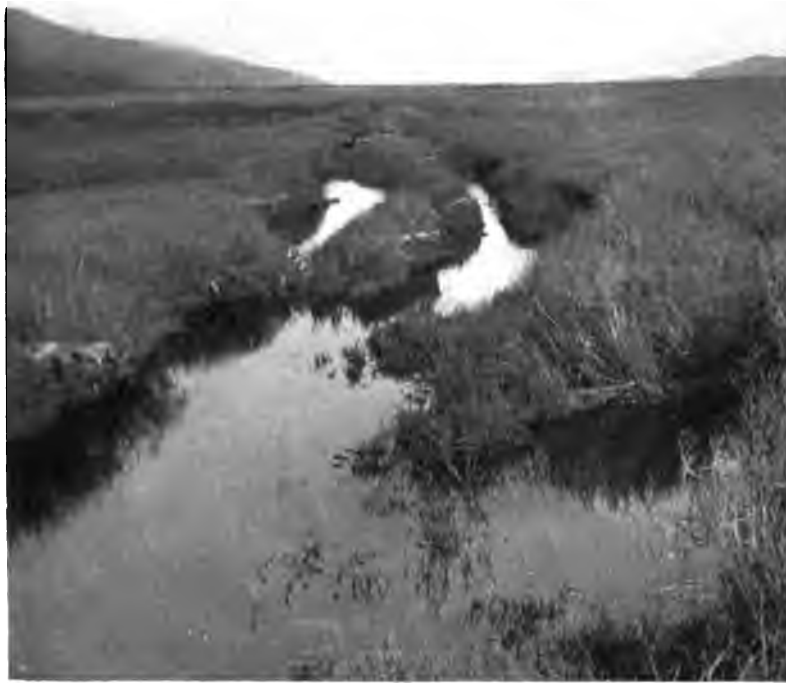
A. Fault-trace on Papermill delta. Looking northwest. G. K. G.

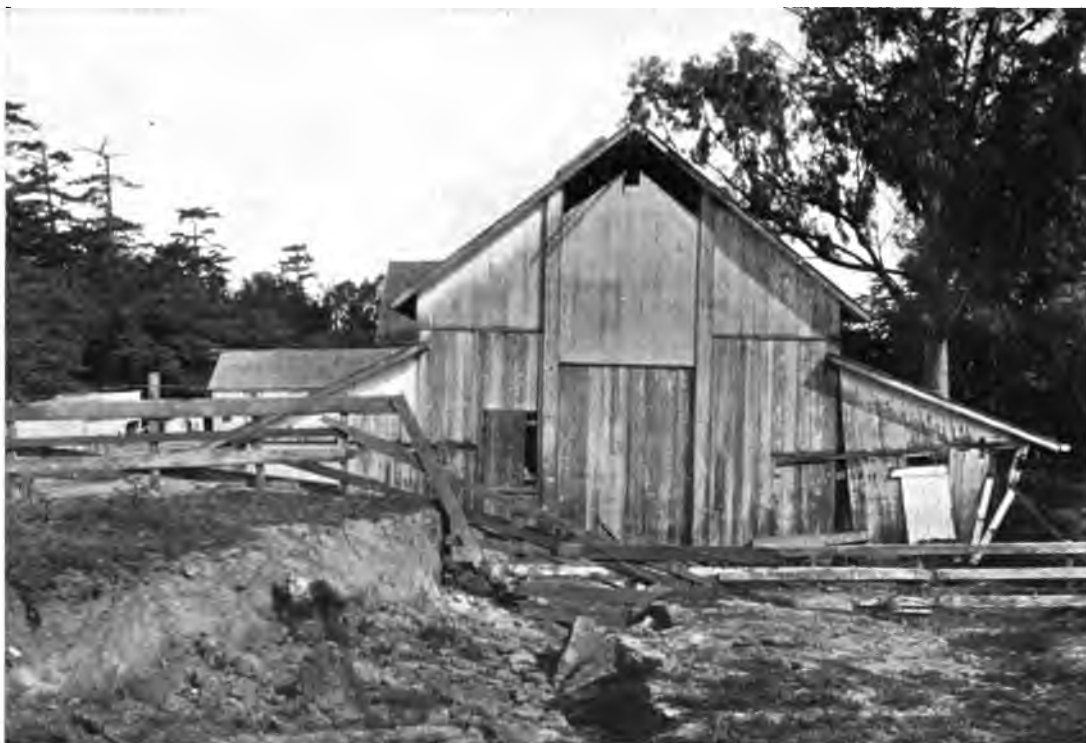
B. Fault-trace at the Skinner place, near Olema. Illustrating trench phase. G. K. G.

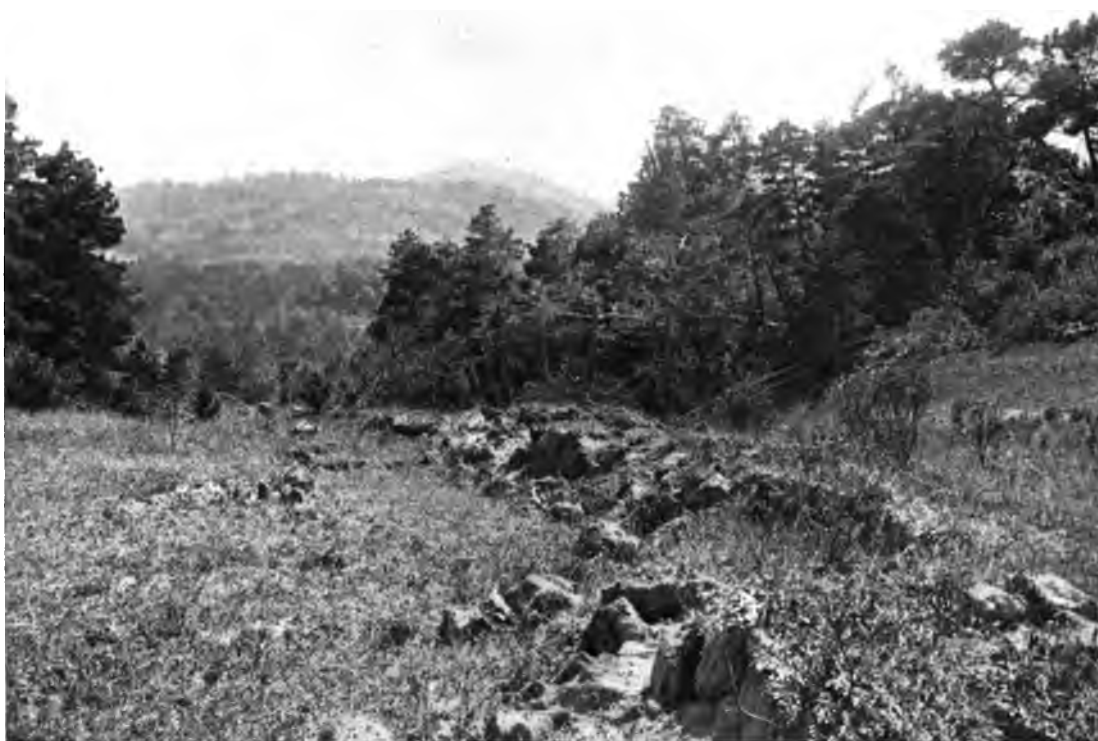
A. Branch of fault-trace on "north mesa" at Inverness. Looking southeast. G. K. G.

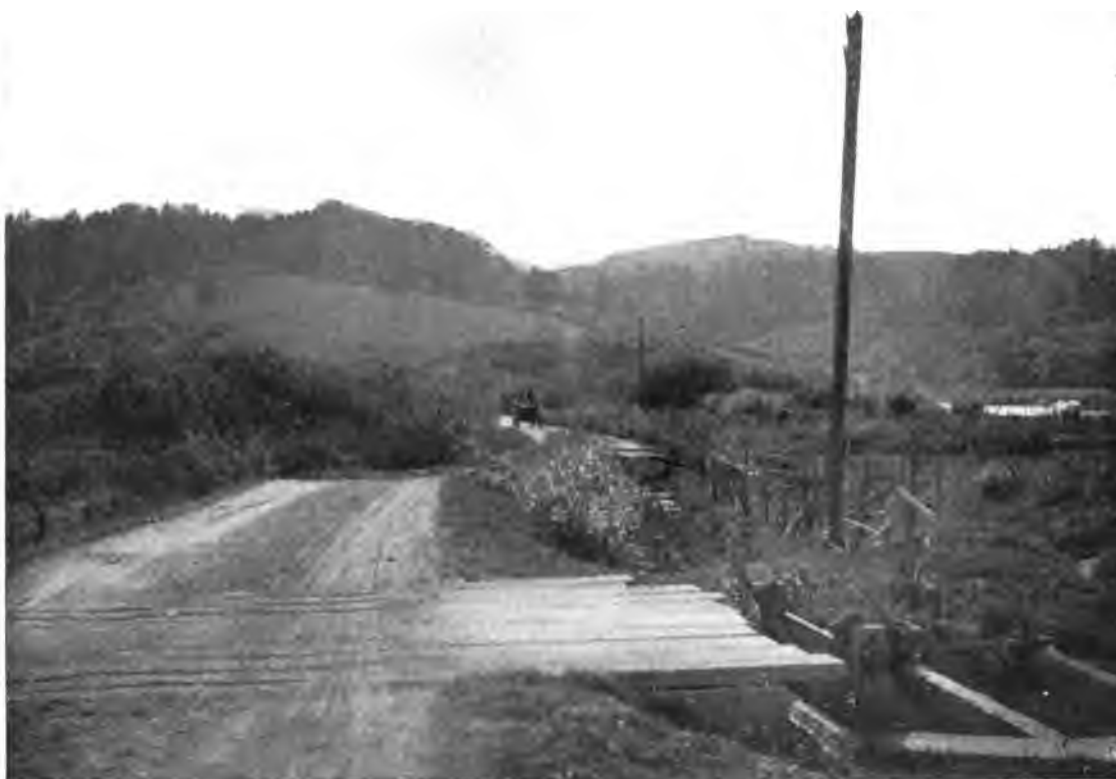
B. Road offset by fault. Looking southwest. G. K. G.

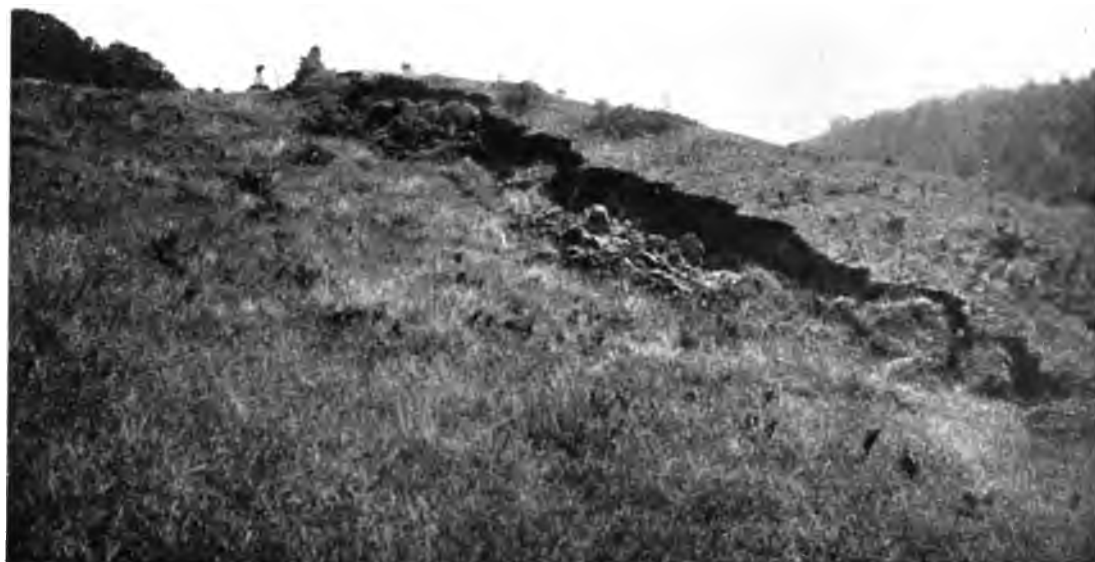
A. Fault-trace a mile northwest of Olema. Looking south. Appearance of vertical displacement largely due to combination of horizontal displacement with slope of ground. G. K. G.

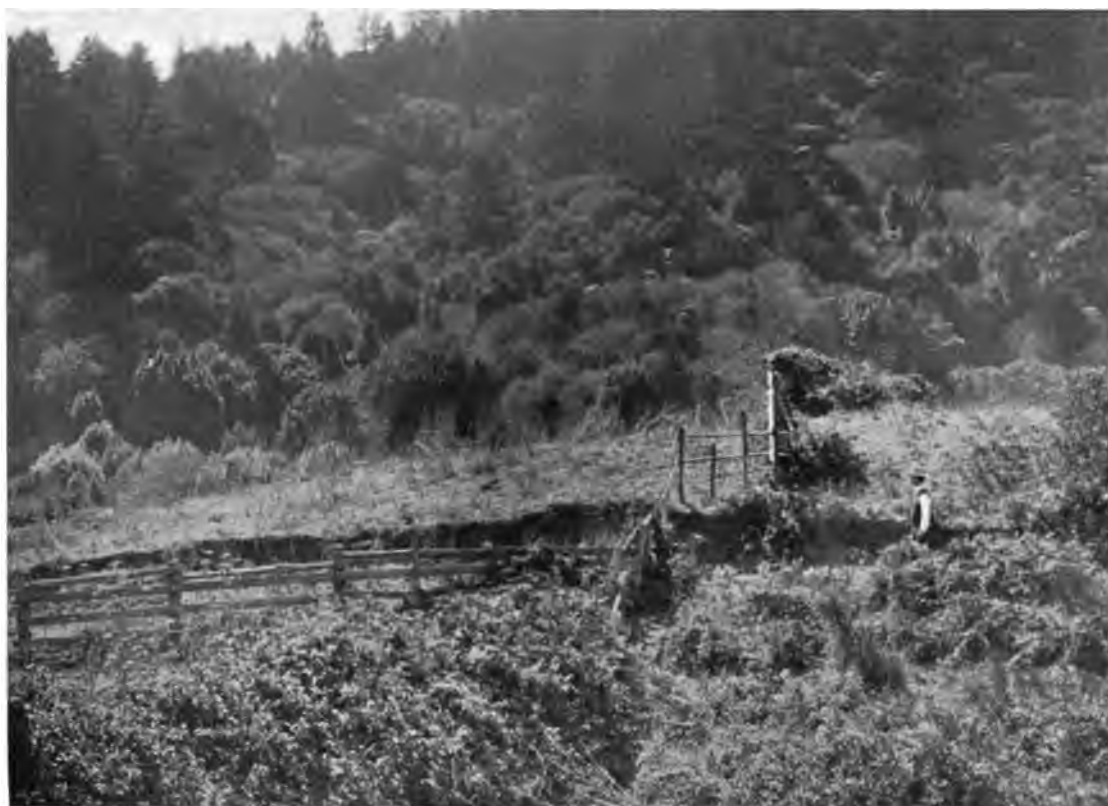
B. Fault-trace near Bondietti's ranch. Looking southwest. Shows vertical displacement bordering a sag. Horizontal displacement shown by fence, which had been repaired. G. K. G.

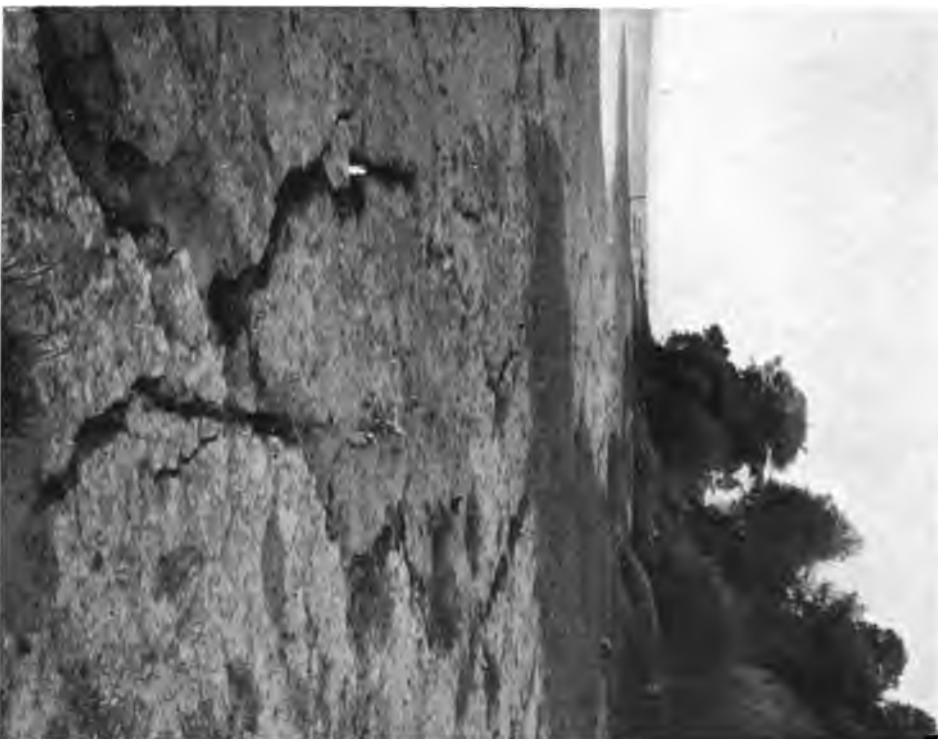
B. Cracks made by earthquake in tidal mud near head of Bolinas Lagoon. G. K. G.

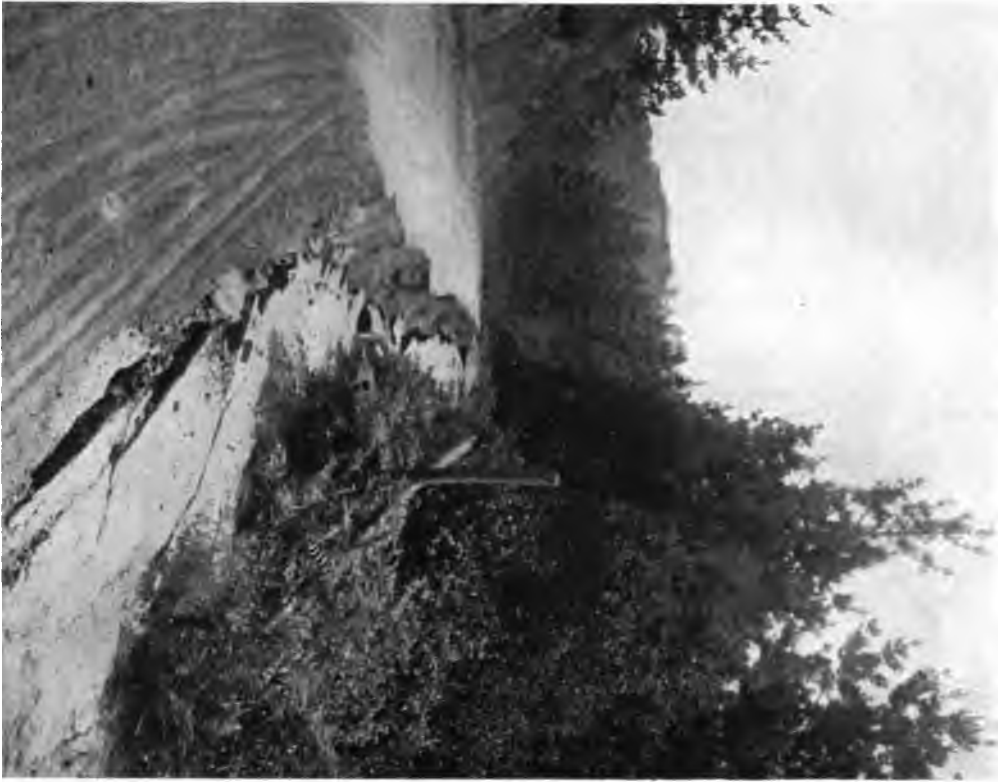
A. Roadside crack 2 miles west of fault, between Inverness and Point Reyes P. O. G. K. G.

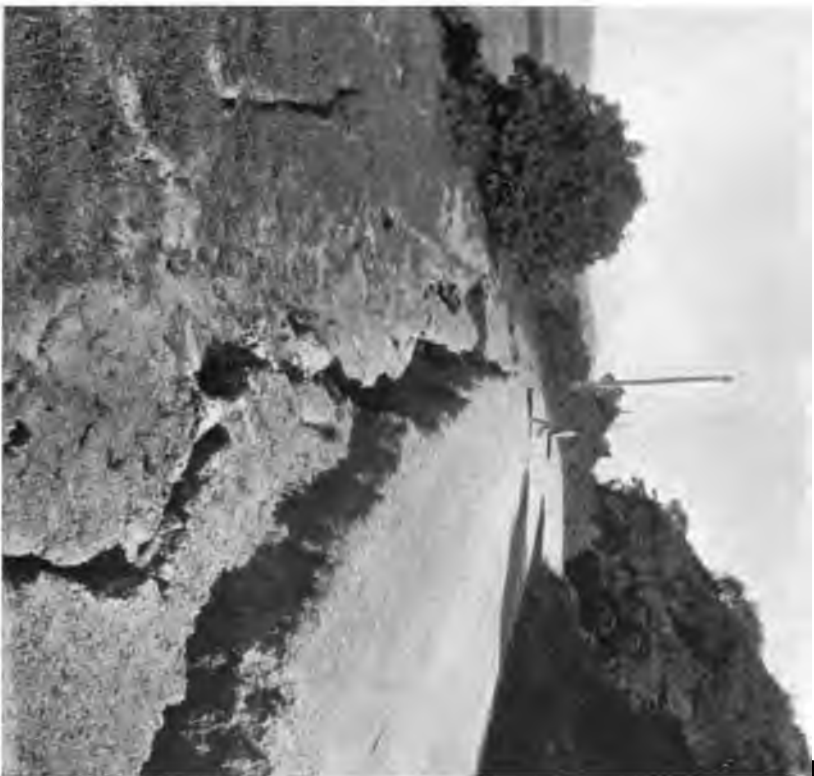
B. Roadside crack 2 mile southeast of Inverness. G. K. G.

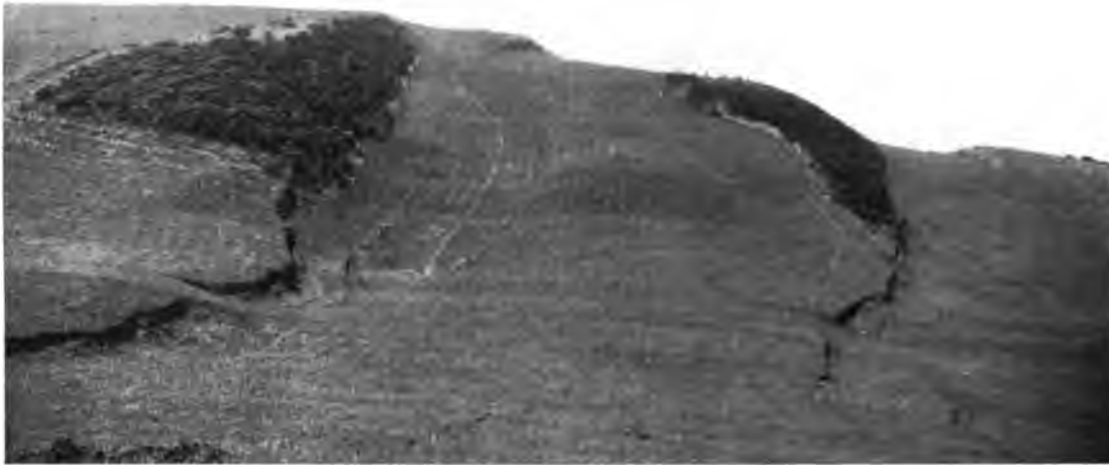
A. Group of earthquake cracks southwest of head of Pine Gulch Creek. Looking southwest. Structure well indicated by sky line. Since dislocation field has been plowed and farm road graded up fault-scarps. Compare Plate 53 A. G. K. G.

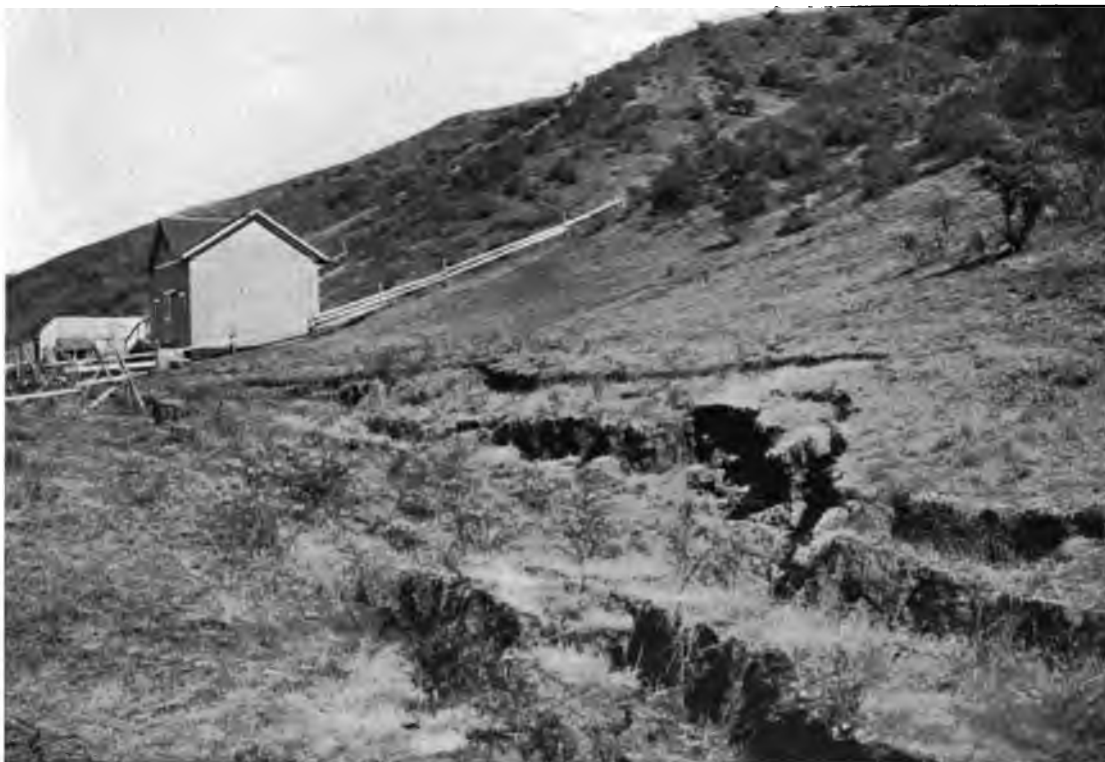
B. Earthquake cracks in Bolinas at edge of an earthquake sag. G. K. G.

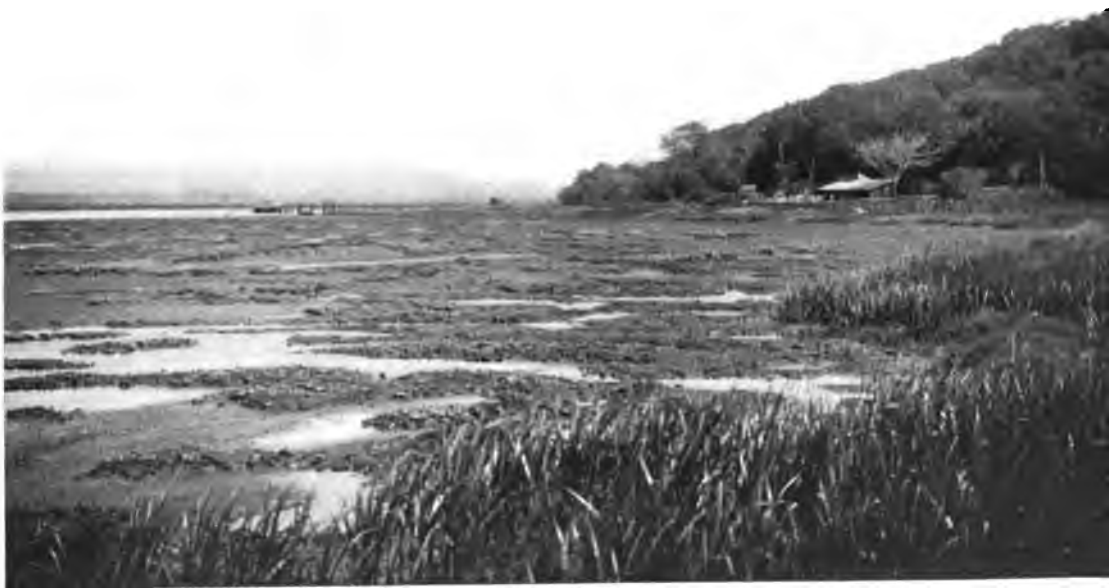
B. Ridged mud plain 1 mile from Inverness. Looking east-southeast. Mr. Hamilton's barn at right. April 28, 1906. Tide is low. Pools occupy the deeper troughs. G. K. G.

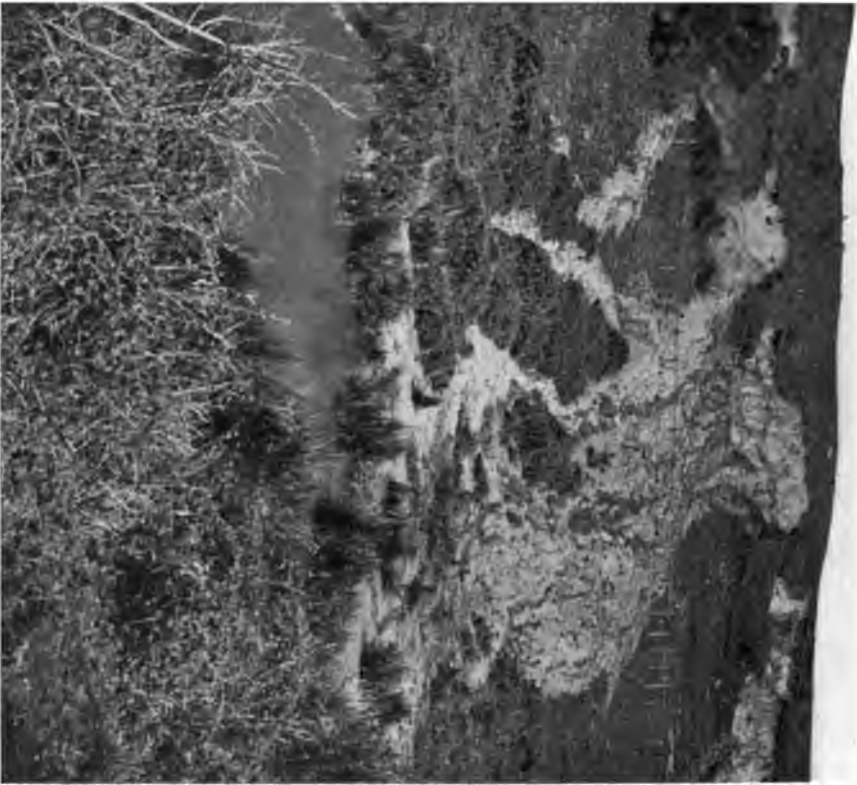
A. Landslides 2.5 miles north west of Bolinas Lagoon. Looking northeast. Storm waters of 1907, guided by earthquake cracks, converted earth into soft mud. G. K. G.

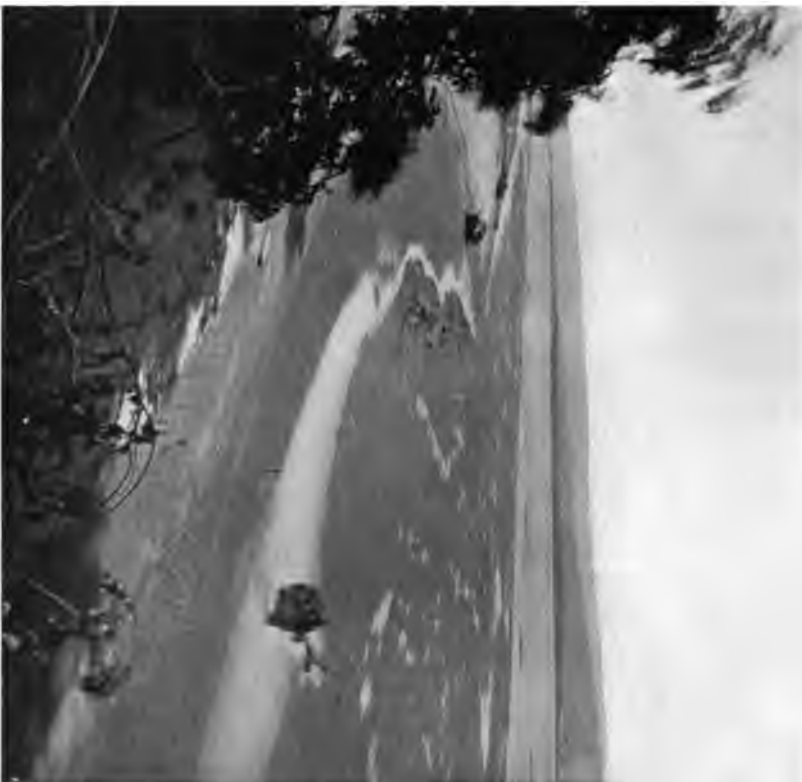
B. South part of Inverness shoal, at low tide, April 28, 1906. Looking north-northwest. Lane of water separates firm, gravelly beach from mud shifted shoreward by earthquake. G. K. G.

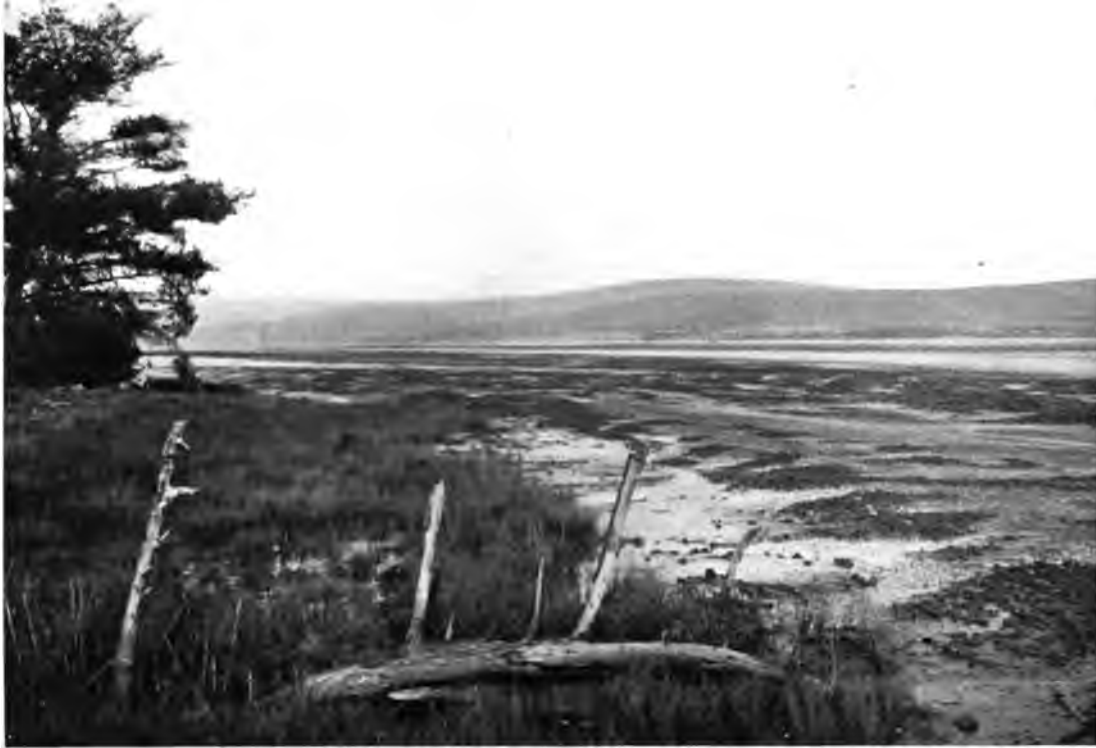
A. Ridges caused by earthquake on tidal flat of Tomales Bay, 1 mile south of Inverness. Looking north. December, 1906. G. K. G.
